ON ROAD TEST
EVALUATION OF IMPACT OF WET NIGHT MARKINGS ON
DRIVER BEHAVIOUR AND ACCIDENTS

RAINVISION

Filename :	RAINVISION_WP4_On Road Test
Code :	RAINVISION/D4.1_v4
Version:	Final
Date:	15/05/2015
WP:	WP4
Category ¹ :	PP
Customer:	European Commission
Grant Agreement:	MOVE/C4/SUB/2010-125/SI2.596617/RAINVISION

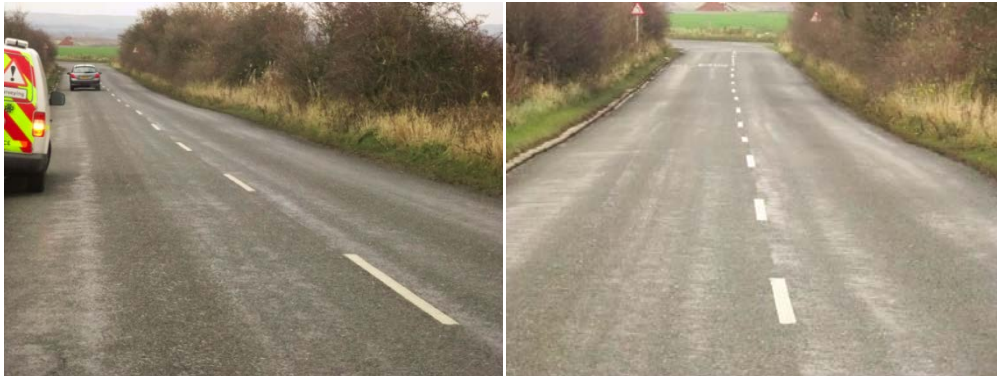
Figure 1: Site 1 Craghead

Description: Rural site, 60mph speed limit. Slight downhill west to east.

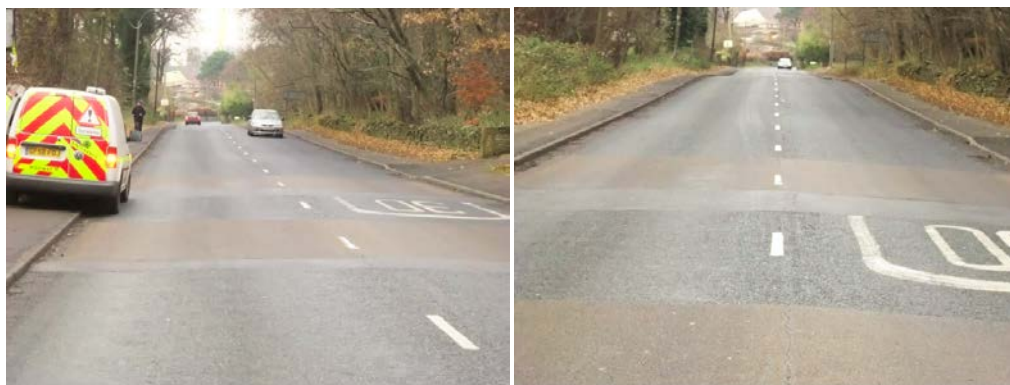
Figure 2: Site 2 Lanchester

Description: Semi-rural site, 30mph speed limit, with gentle slope north to south.

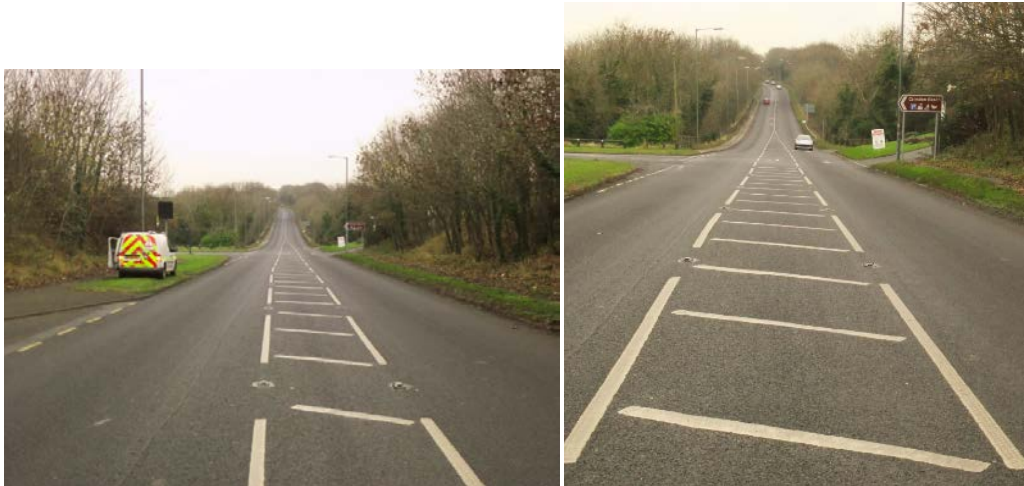
Figure 4: Site 4 Coast Road, Blackhall

Description: Semi rural site, 60mph speed limit, sloping north to south.

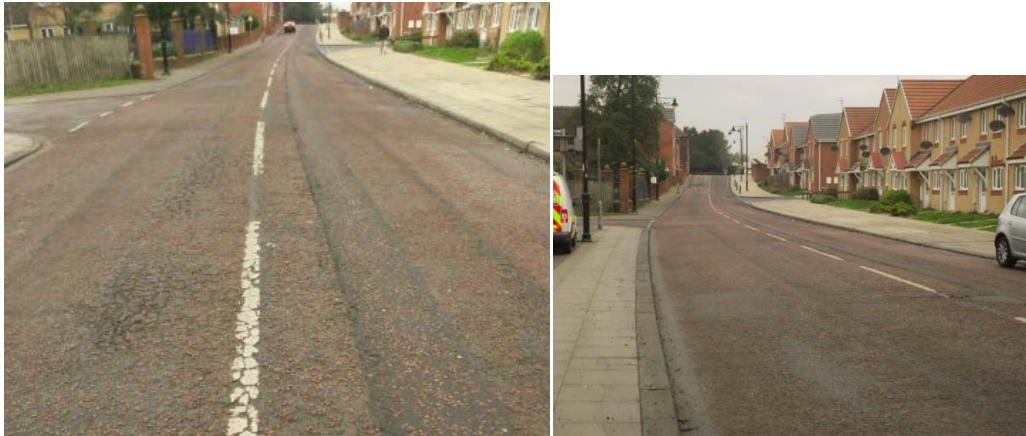
Figure 5: Site 5 Wingate

Description: Urban site, speed limit 30mph, fairly level site.

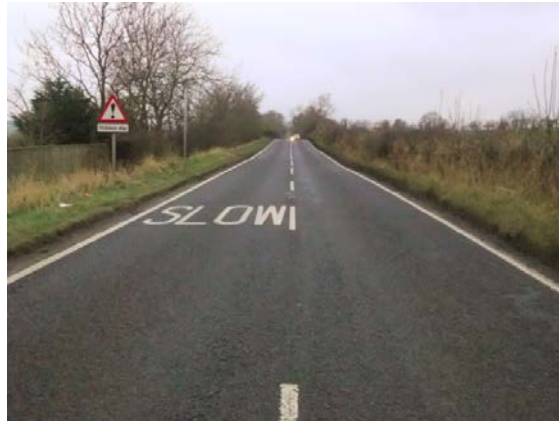
Figure 7: Site 7 High Grange

Description Rural site, fairly level, speed limit 60mph.

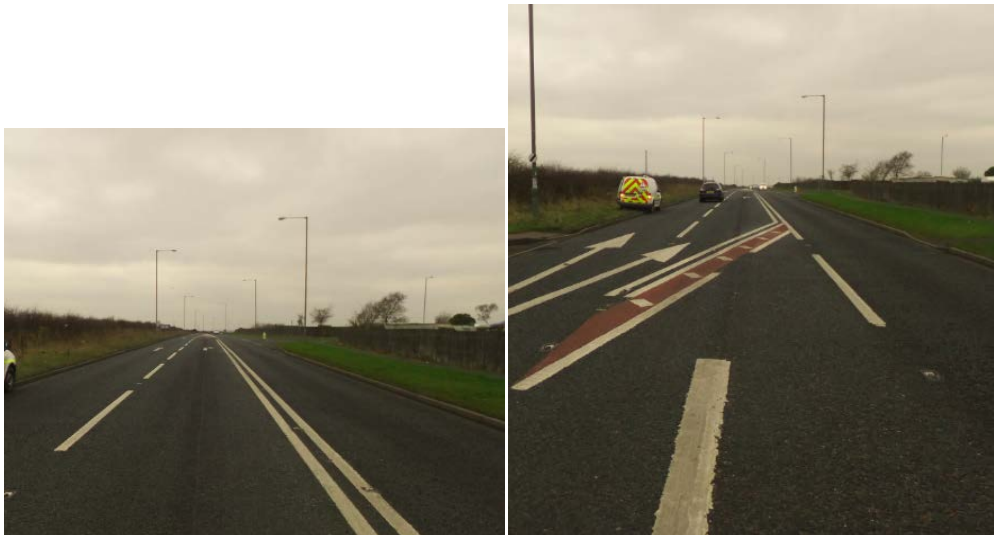
Figure 8: Site 8 Wheatley Hill

Description	Rural site, fairly level, speed limit 60mph.
-------------	--

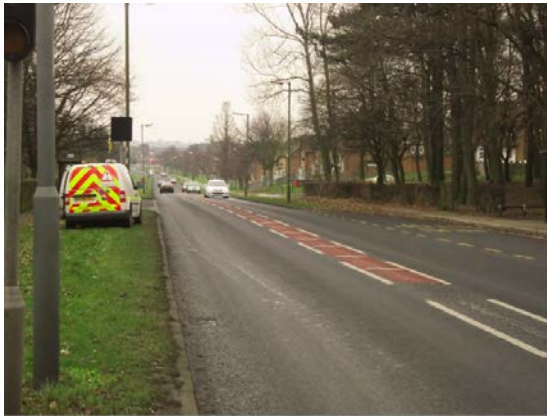
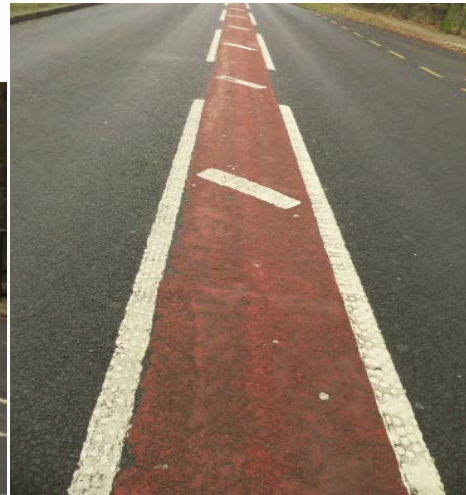
Figure 9: Site 9 Essington Way

Description Urban site, speed limit 30mph, proximity of bus stops on both sides of road.

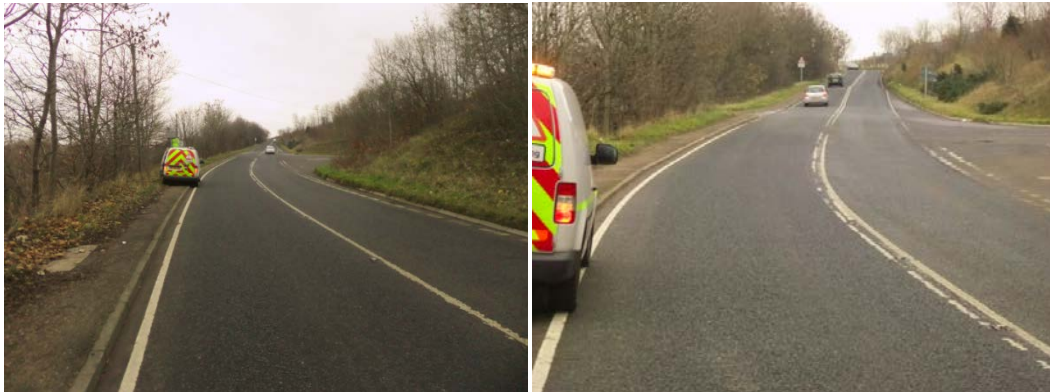
Figure 10: Site 10 Quarrington Hill

Description Fairly sloping site NE to SW, speed limit 60mph, proximity to amenity waste site.

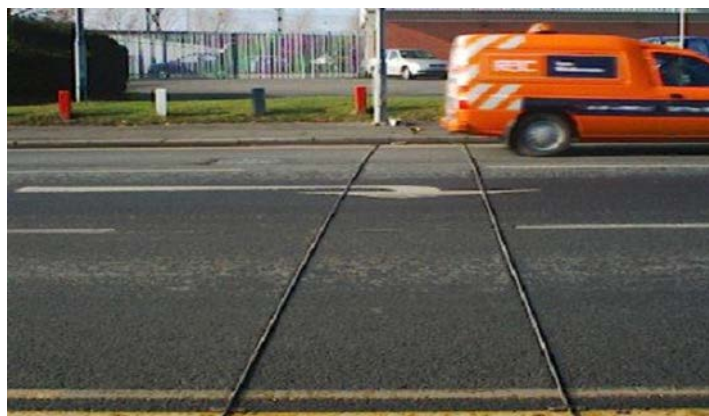
Figure 11: Example of installed Traffic Volume and Speed Measurement Pneumatic Tube

The directionally sensitive raw data sets, collected from the pneumatic tubes (Appendix 4a), were analysed and assessed for each site with average vehicle speeds being calculated on an hourly, daily and weekly basis (Appendix 4b). These average speeds were analysed in such a way as to allow for indicative comparison of data with that taken from Stage 2 of the project – On Road Tests.

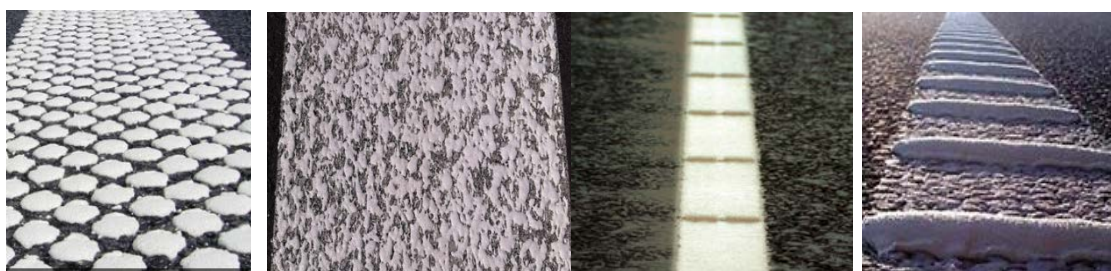
Figure 13: Profiled marking examples

Profiled markings are higher performing than standard thermoplastic or cold plastic markings. They provide very high retroreflectivity, improved water shedding capability, skid resistance and a rumble or noise effect with vehicle contact. Profiled markings can be used on both urban and highway segments, and are most often applied as centre lines, lane lines and edge lines.

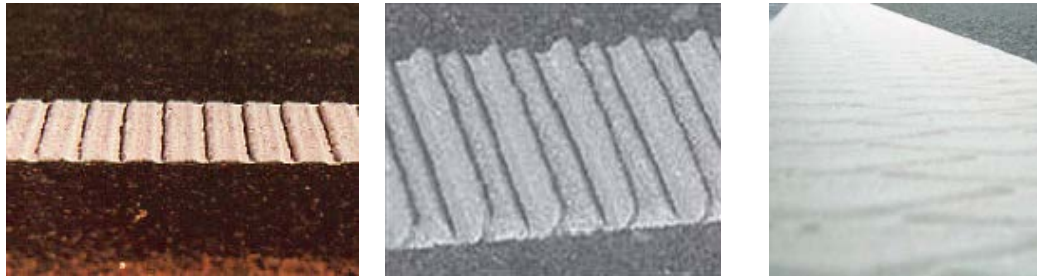
Figure 14: Embossed markings

Contractors apply a base of thermoplastic material spread with glass beads for additional retroreflectivity. Using special equipment, they imprint one of several available patterns on the plastic while it's still pliable (transverse, diagonal, diamond, gear and multi-dot patterns available). The equipment creates a “stamp” on the plastic that allows water to drain from the line. The benefits are equivalent to that of a profiled marking.

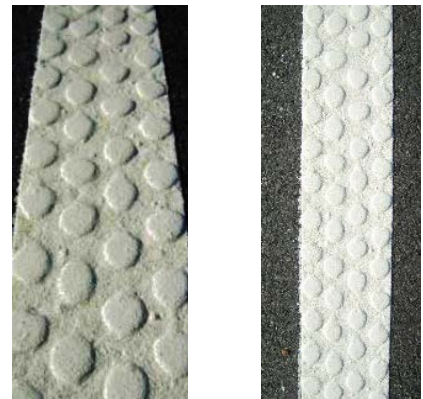
Figure 15: Wet night markings

During August and September of 2012 a Road Safety Markings Association contracting member installed a Wet night visibility performance product on all 10 sites. The longitudinal lines on the sites were laid with the Line 'n' Dot road marking system. The material used was a thermoplastic road marking material consisting of a mixture of aggregate, pigment, extender, synthetic resins, mineral oil and glass beads blended and supplied in granular form (see full specification Appendix 7).

It is designed for producing structured markings via extruder application, however can also be laid through any thermoplastic road marking equipment, hand mould or pram.

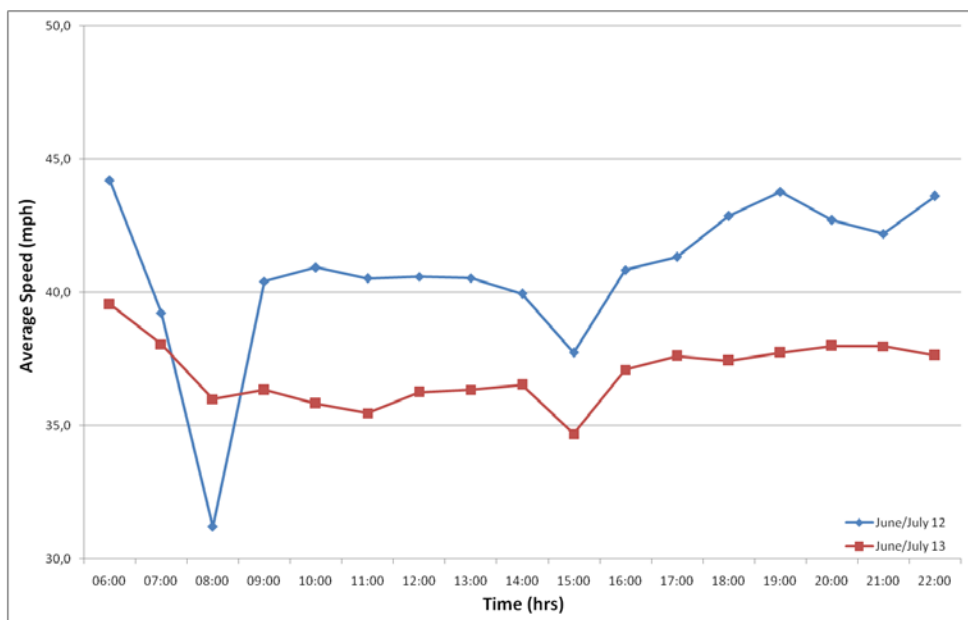
Figure 21: Average Speed v Time Site 2 Northwestbound – June/July 12 – June/July 13

June to June (northbound vehicle data only). General decrease in speeds from June '12 to June '13 of between 3mph and 6mph. Speeds drop around morning commuting as well as afternoon school leaving times, and may therefore result from school buses travelling in the area.

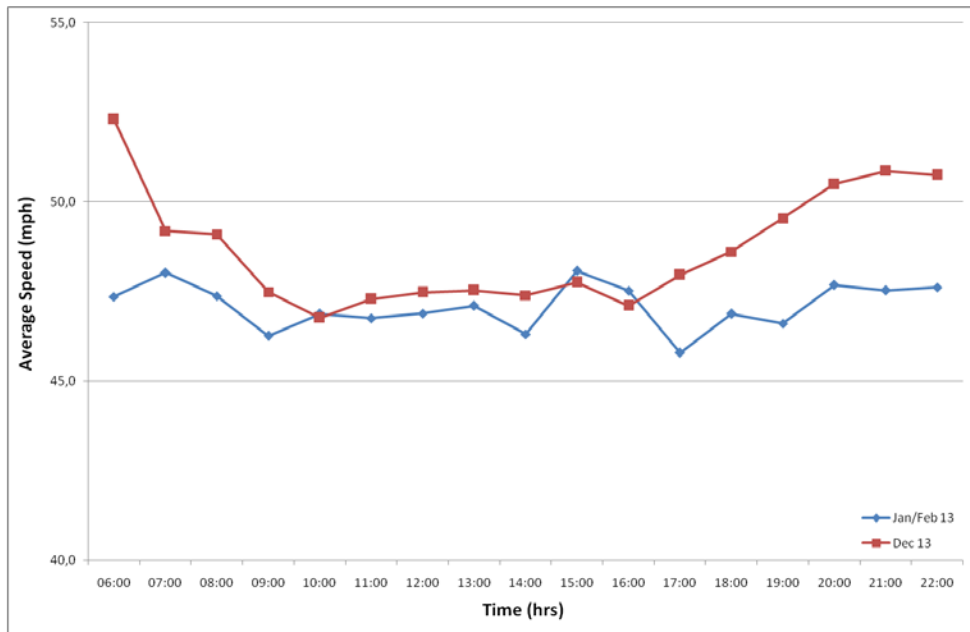
Figure 26: Average Speed v Time Site 4 Southbound - Jan/Feb 13 - Dec 13

December to December (southbound vehicle data only) vehicle speeds generally marginally elevated from Jan '13 to Dec '13.

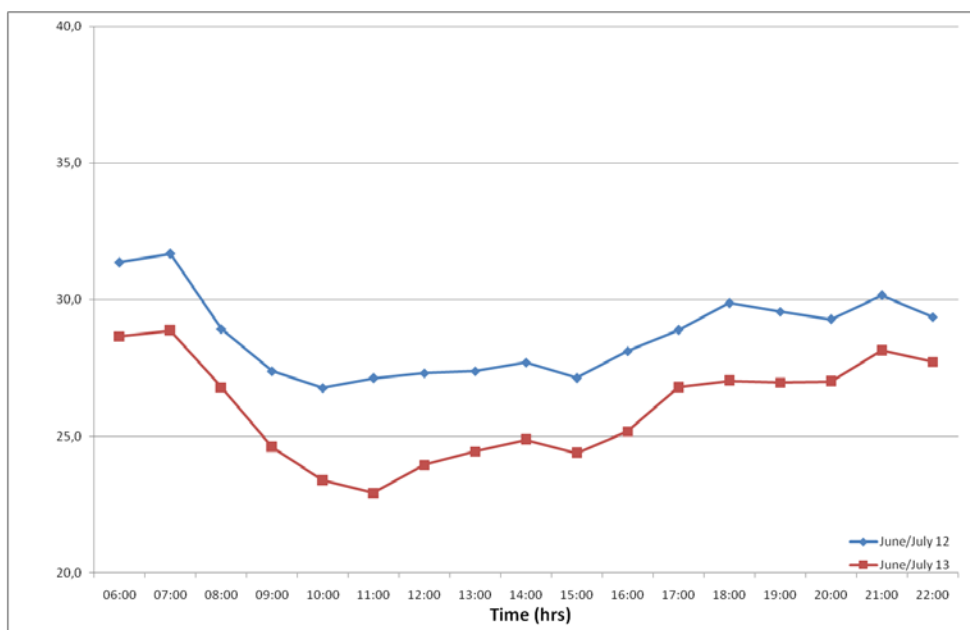
Figure 27: Average Speed v Time Site 5 Northbound – June/July 12 – June/July 13

June to June (northbound vehicle data only). General minor decrease in speeds from June '12 to June '13 of between 1.5mph and 3.5mph. Speeds drop around morning commuting as well as afternoon school leaving times, and may therefore result from school buses travelling in the area.

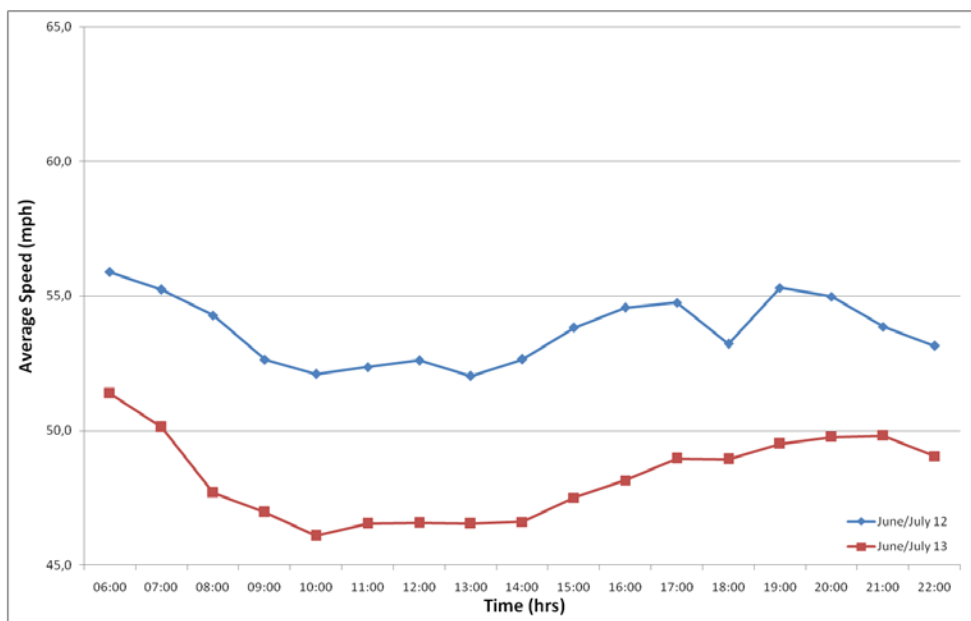
Figure 29: Average Speed v Time Site 6 Northbound – June/July 12 – June/July 13

June to June (northbound vehicle data only). General decrease in speeds from June '12 to June '13 of between 4mph and 6mph. Vehicle speeds trend to drop steadily from around morning commuting and rise again from around 10am.

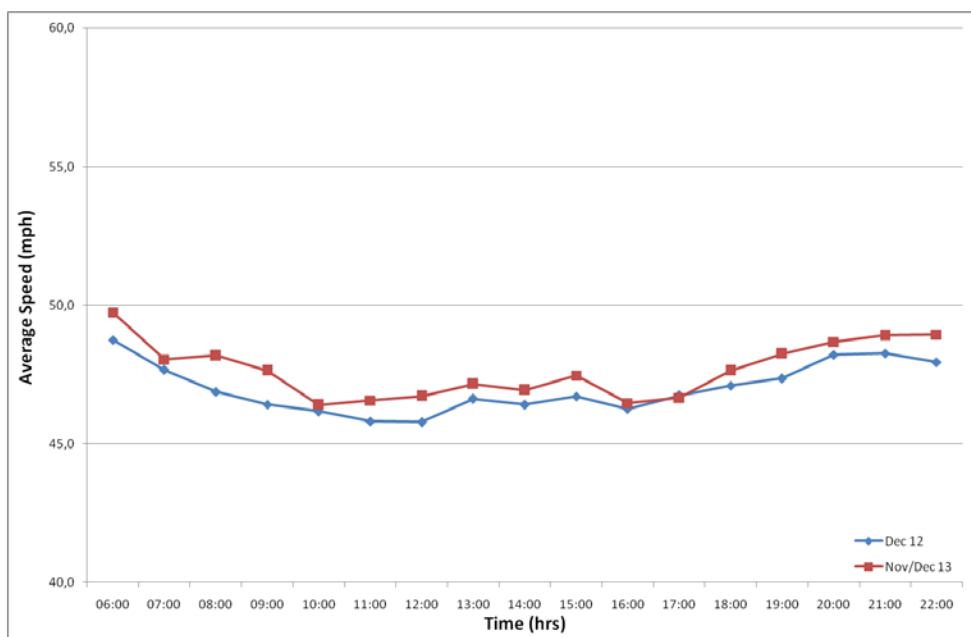
Figure 30: Average Speed v Time Site 6 Northbound – Dec12 – Nov/Dec 13

December to December (northbound vehicle data only) vehicle speeds generally marginally increased (0.0mph – 1.25mph) from Dec '13 to Dec '13. Speeds drop by approximate 3.5mph during morning traffic remaining low during the day (approximately 42mph) and steadily increase throughout the late afternoon following commuting traffic times.

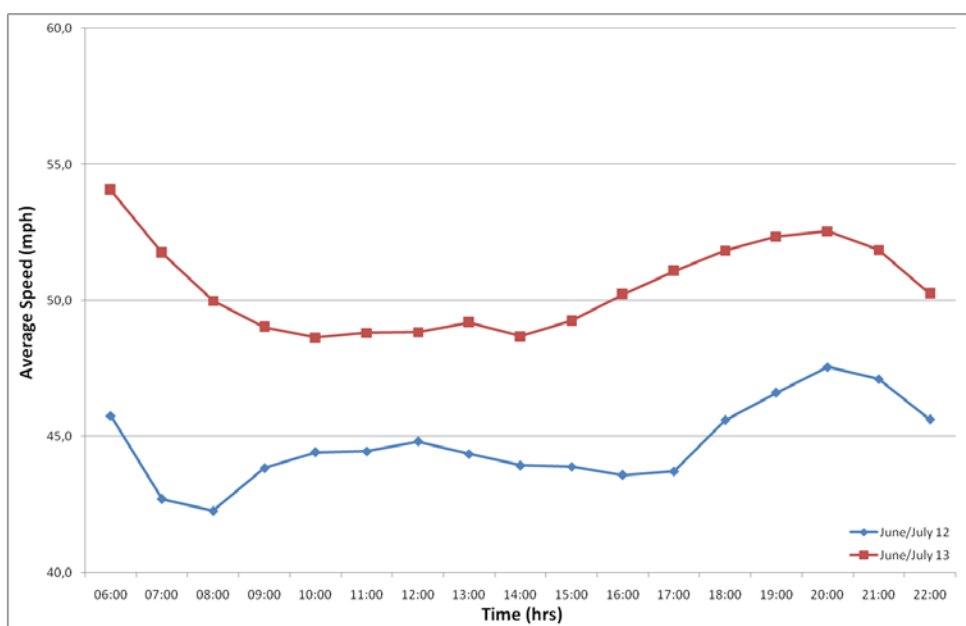
Figure 33: Average Speed v Time Site 8 Westbound – June/July 12 – June/July 13

June to June (westbound vehicle data only). General increase in speeds from June '12 to June '13 of between 4.0mph and 8.75mph. Speeds drop steadily from around morning commuting as and rise again in the evening between 5pm – 9pm before dropping again into the late evening.

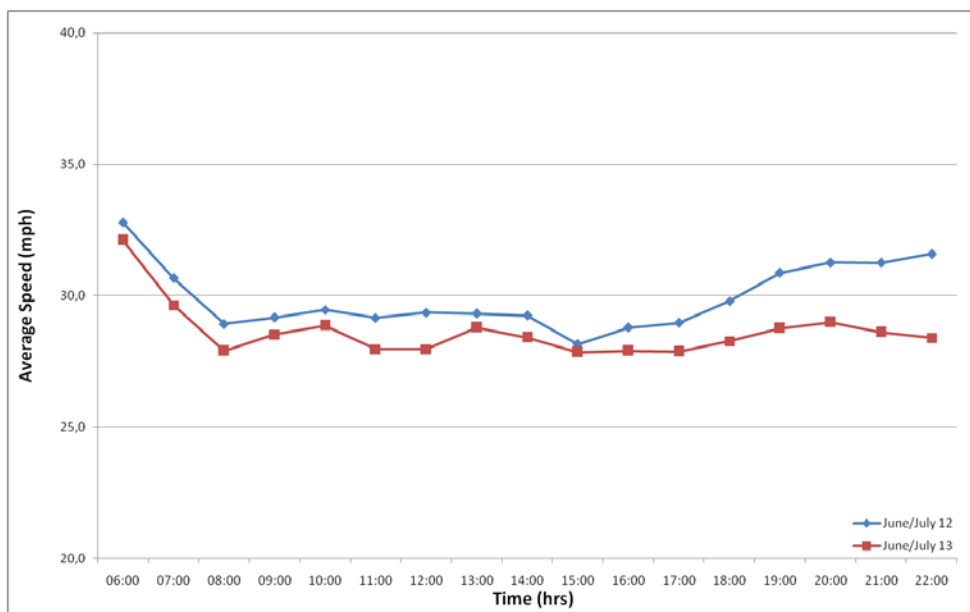
Figure 35: Average Speed v Time Site 9 Northbound – June/July 12 – June/July 13

June to June (northbound vehicle data only). General minor decrease in speeds from June '12 to June '13 of between 0.5mph and 3.0mph. Speeds drop by around 4mph around morning commuting and rise slightly again following afternoon school leaving times, and may therefore result from buses including school buses travelling in the area.

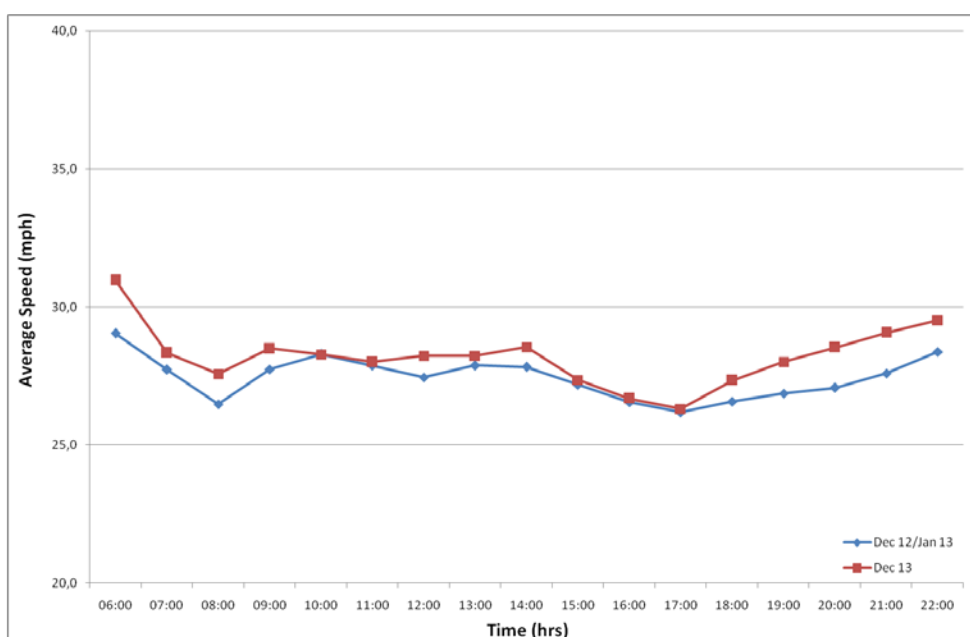
Figure 36: Average Speed v Time Site 9 Northbound – Dec12/Jan 13 – Dec 13

Dec to Dec (northbound vehicle data only). General minor increase in speeds from June '12 to June '13 of between 0mph and 2.0mph. Speeds drop by around 3mph around morning commuting and rising slightly thereafter and display a small drop and slow rise around afternoon school leaving times, and may therefore result from buses including school buses travelling in the area.

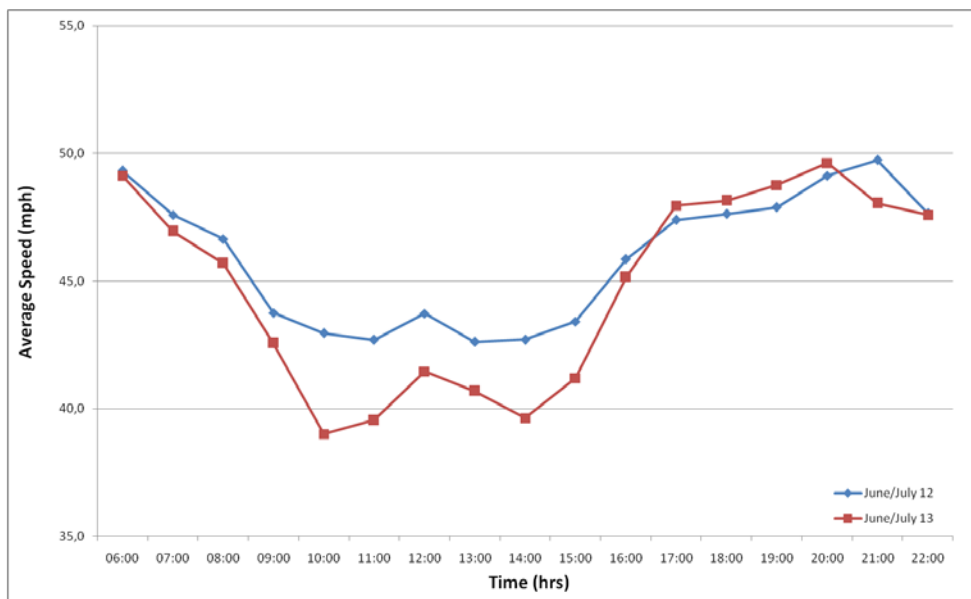
Figure 37: Average Speed v Time Site 10 Southwest bound – June/July 12 – June/July 13

June to June (southbound vehicle data only). General minor decrease in speeds from June '12 to June '13 of between 0.5mph and a maximum difference of 4.0mph decrease around late morning / lunchtime. Speeds drop by around 10mph around morning commuting and rise again to the same levels between early-late afternoon.

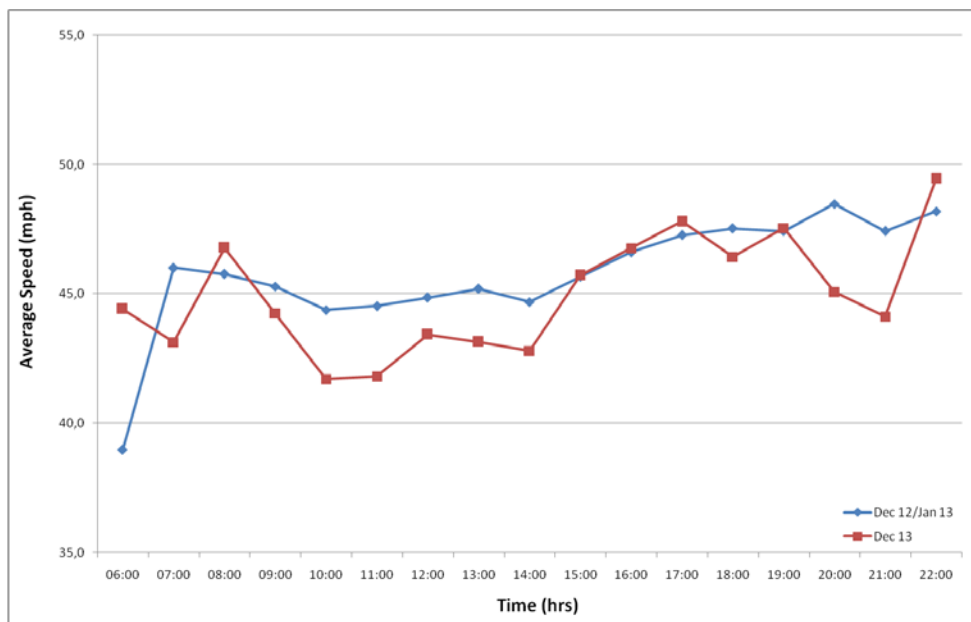
Figure 38: Average Speed v Time Site 10 Southwest bound – Dec12/Jan 13 – Dec 13

Dec to Dec (southwest vehicle data only). General fluctuations in speeds from Dec '12 to Dec '13 of between -3,5mph and +1,0mph. Speeds generally steadily increase throughout the day with a range of approximately 8mph between the start of the day and end of day recordings.
